<p>Purpose of Survey</p>	<p>The inspection was requested by Wendy Evans, owner of the property.</p> <p>Having undertaken Pre-Application discussions with the Local Authority Planners, Ms Evans is considering changing the use of the premises to Holiday Let.</p> <p>The purpose of the report is therefore to establish the structural condition of the building in support of a Planning Application paying due regard to the general condition of the building and its suitability for renovation to holiday let accommodation.</p>
<p>Brief</p>	<p>Brief agreed with Ms Rhiannon Morgan of Dewis Architecture, on behalf of Ms Evans, in EWP email dated 7th January 2020, reference Q1141, and instructed by email from Ms Rhiannon Morgan, on behalf of Ms Evans, dated 13th May 2020.</p> <ul style="list-style-type: none"> • Undertake site visit to review condition of existing property including inspection of trial holes, • Provide report on findings including any recommendations for further intrusive investigations or specialist inspections, • Make comment on the trial hole findings with relation to suitability for conversion, • Make comment on the condition of the building and its suitability for the propos

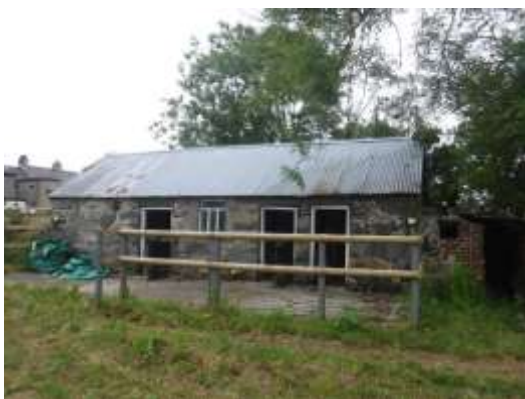
01 - front (north east) elevation

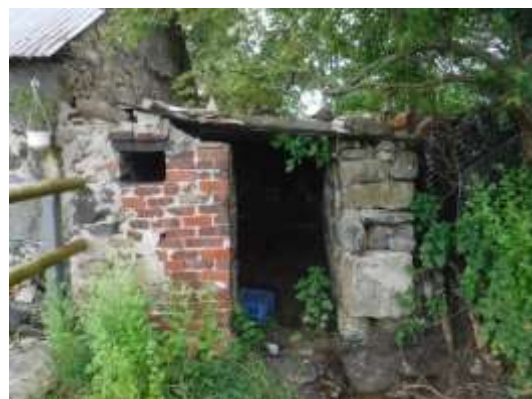
<p>Front elevation (photos 01-03, 08-11, 30)</p>	<ul style="list-style-type: none"> • The inspection found the front elevation wall to room 4 to consist of a mix of stonework and brickwork and in poor condition towards its head (photo 02 and 12). • The inspection noted repointing to the central section of wall between the doors to room 1 and room 2. The pointing was flush with the face of the stonework and appears of a “hard” cementitious type material (photo 09). Towards the base of the wall the recent pointing is remote from the substrata and the growth of moss indicates that the wall becomes saturated. • A fall to the right of the door frame to the entrance to room 1 was noted, however the stone surround appeared square.
<p>South-east Gable Elevation (photos 13-16)</p>	<ul style="list-style-type: none"> • Whilst the growth of ivy partially obscured the elevation (photo 13), a slight inwards lean of the gable pike was noted. Internally it was noted that stonework was missing towards the head of the pike (photo 34). • Where tree stumps remained to the right-hand side of the elevation a vertical crack was noted in the stonework, albeit a close inspection was not available due to vegetation growth (photo 14). Internally in this location a vertical crack was noted running from a 4mm wide crack at ground floor to an approximately 50mm wide crack at the bearing of the front purlin (photo 33).

02 - front elevation room 04

It is further recommended that the front section of the north-west gable wall in room 4, which was observed to bulge inwards, is reconstructed plumb above the retained ground level, and that the poorly constructed upper section of brickwork / masonry to the front elevation is rebuilt to ensure long term structural integrity.

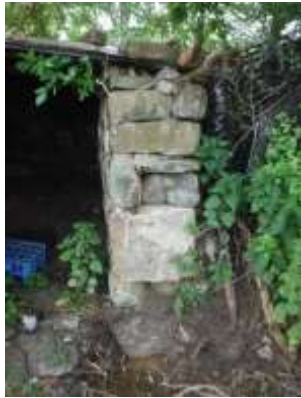
03 - left hand end of north-west gable wall - note slight inward lean

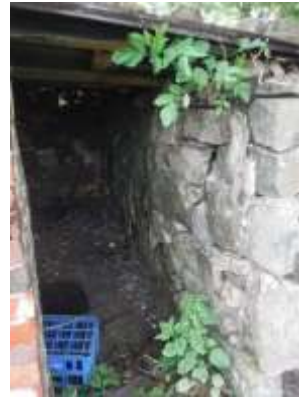
04 - inside of north-west gable wall - note inward bulge local to end of wall

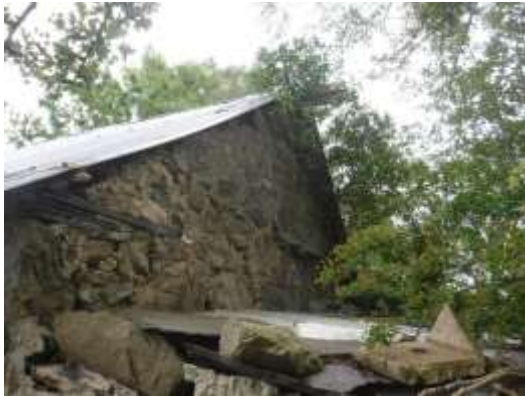
05 - gable pike to room 3

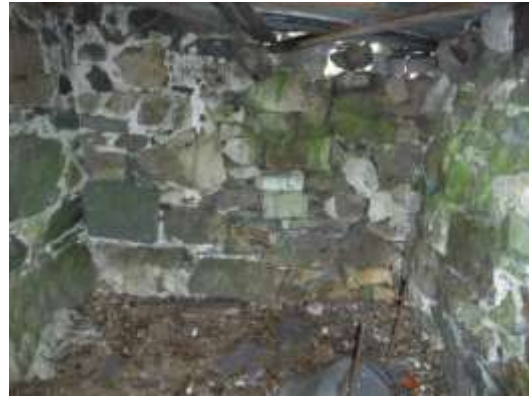
06 - rear wall to room 4 - note loose stone infill to upper right-hand side

Within room 4 the rear section of "loose laid" stonework should be rebuilt using a suitable lime-based mortar to provide structural integrity.

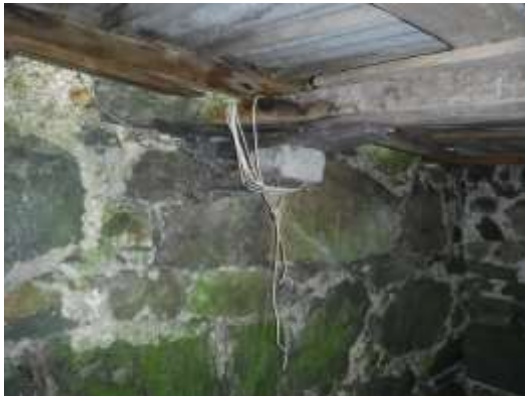
07 - temporary roof structure over room 4

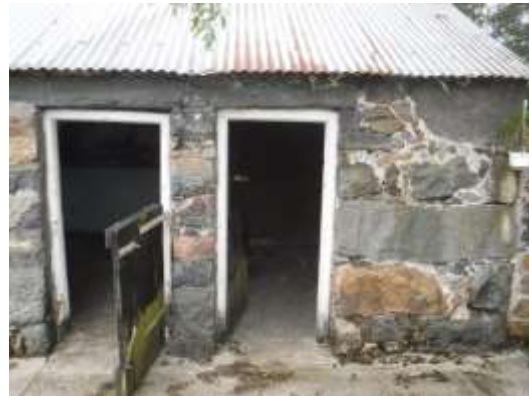
08 - front elevation to Room 02 and room 03 - note slope to left hand door frame does not extend to structural door head which appeared square

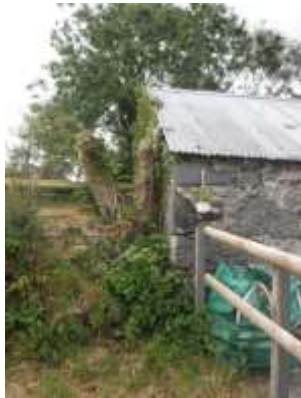
11 - tree located adjacent to south-east elevation

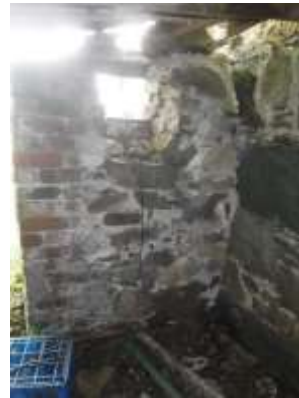
12 - inside of front wall to room 4

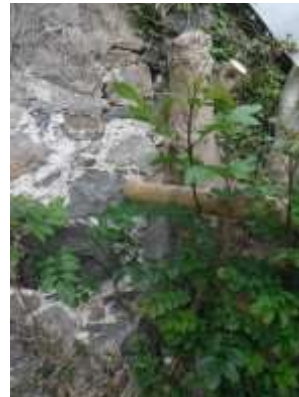
The crack to the south east gable to room 1 appears most likely associated with the growth of the tree immediately adjacent to the front corner of the building, most likely due to the physical growth of the stump and roots, rather than the effect on the bearing stratum which is predominantly sandy in nature. The remains of the tree should be removed, and the wall locally repaired / rebuilt as required to ensure the long term structural integrity.

14 - south east elevation - note vertical crack adjacent to tree stump

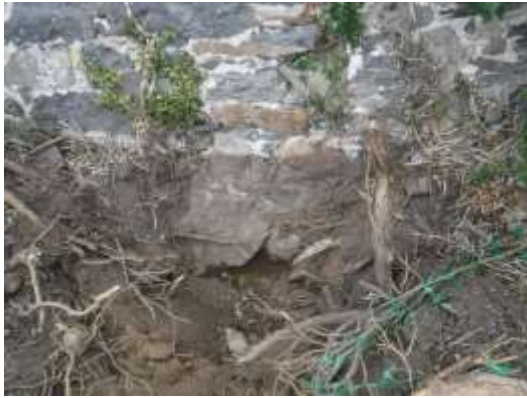
<p>of the building General (photos 24-34)</p> <p>Trial holes</p> <p>TH1 (photo 15)</p> <p>TH2 (photo 18)</p> <p>TH3 (photo 03)</p>	<ul style="list-style-type: none"> • The inspection found no structural defects of note other than those referenced above relating to corresponding defects in the external elevations. • The trial hole excavation found the stone wall to continue to approximately 800mm below ground level. It is noted that the gable wall retains approximately 400mm in this location. The stone wall increased in thickness by approximately 200mm and was founded on a very dense slightly silty, shaley sand with frequent cobbles. • The trial hole excavation found the stone wall to continue to approximately 800mm below ground level. It is noted that the rear wall retains approximately 400mm in this location. The stone wall increased in thickness by approximately 200mm and was founded on a very dense slightly silty, shaley sand with frequent cobbles. • The trial hole excavation found the stone wall to continue to approximately 840mm below ground level. The wall was founded on a very dense slightly silty, shaley sand with frequent cobbles.

15 - south-east elevation - trial hole 1

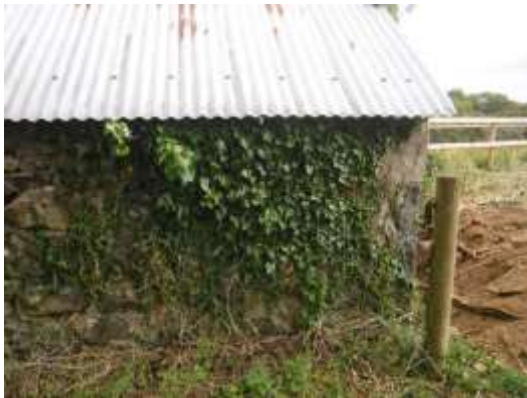
17 - rear elevation to room 1

Where ivy growth is removed, repointing should be undertaken as necessary.

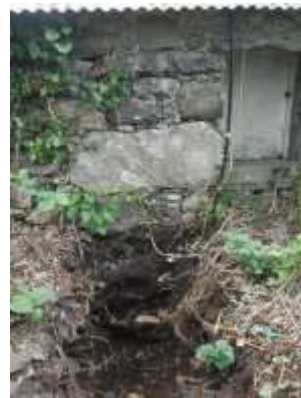
18 - rear elevation - trial hole 2

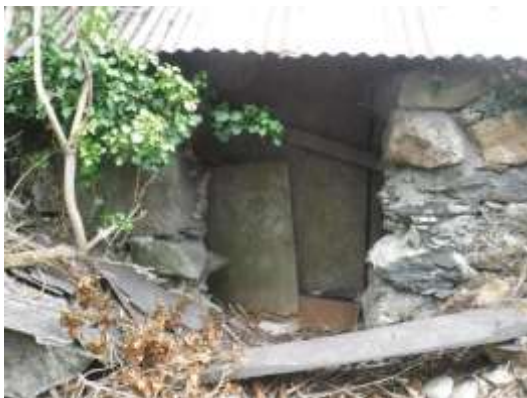
19 - rear elevation - temporary opening

The crack in the division wall between rooms 2 and 3 appears due to the disruption to the stonework caused by the formation of the temporary entrance to the rear. We recommend that the stonework to the rear be made good including local rebuilding of the internal return wall as required.

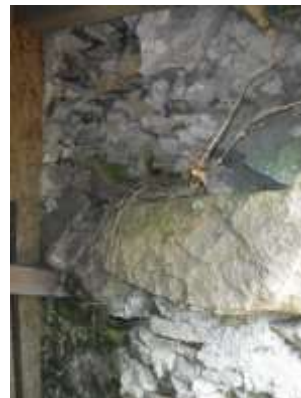
20 - missing stonework to division wall between room 3 and room 2 adjacent to temporary opening

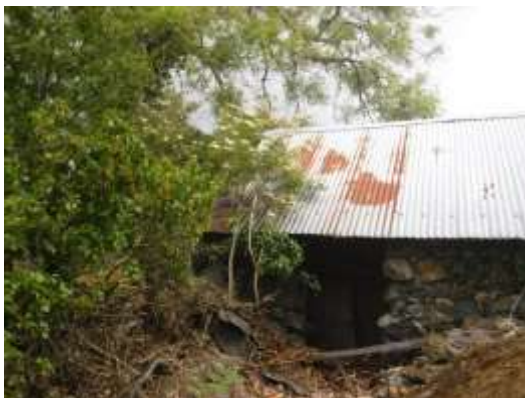
23 - junction of rear elevation and north-west gable - note adjacent tree

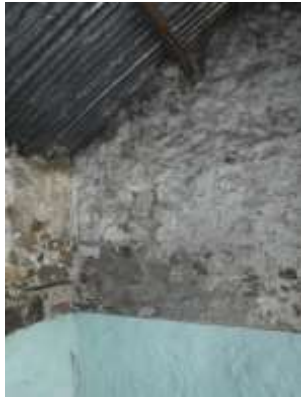
27 - vertical stepped cracking to rear of wall between rooms 2 and 3 - from room 2 - note missing stonework on far side of wall

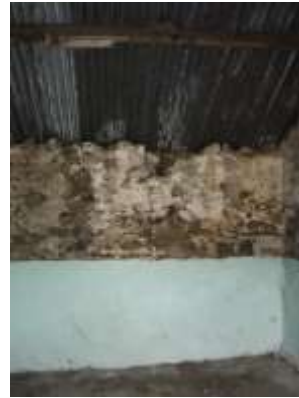
28 - inside of rear wall to room 2 - note uneven eaves level

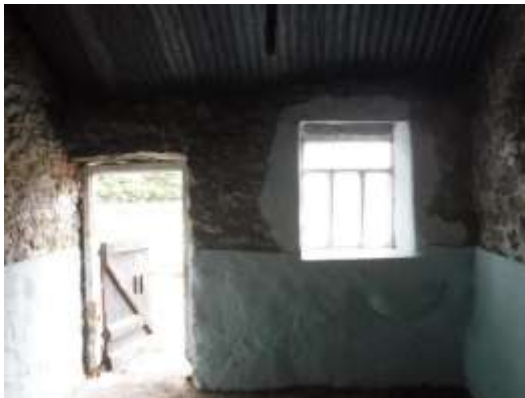
29 - inside of front wall to room 2 - note dropped door frame but square door head

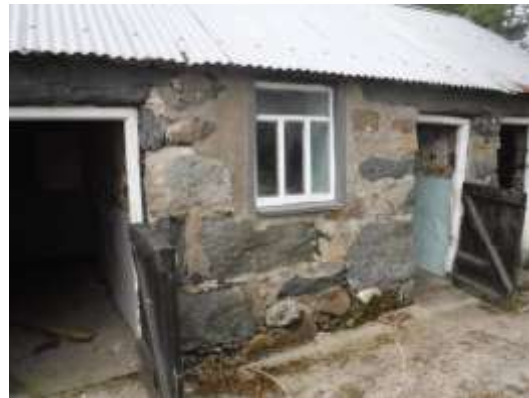
To the front elevation, between the entrance doors to rooms 1 and 2, historic repointing indicates that the panel may have been subject to weathering previously. Moss present to the base of the wall indicates a degree of ongoing saturation. This in turn appears to have led to further degradation of the original soft pointing and debonding of the more recent pointing. It is

30 - front elevation wall between doors to room 1 and room 2 - note smooth, hard repointing works

recommended that the "hard" repointing in the panel is removed and that it is repointed in a lime-based mortar. Any renovation works should then address the cause of the saturation including the potential installation of rainwater good and removal of the concrete slab which abuts the front elevation potentially causing splash back.

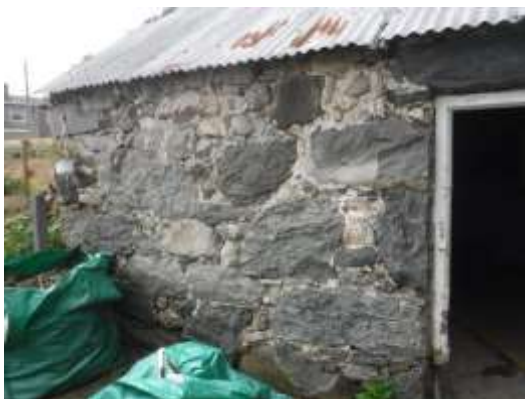
31 - front elevation to room 1 - large stones with smaller stone infill

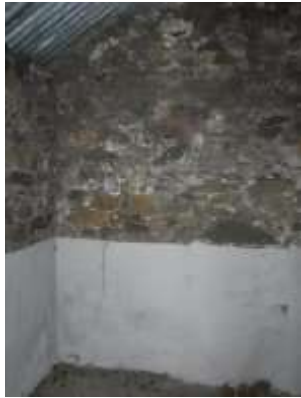
33 - inside of room 1 gable wall - note vertical crack becoming wider with height

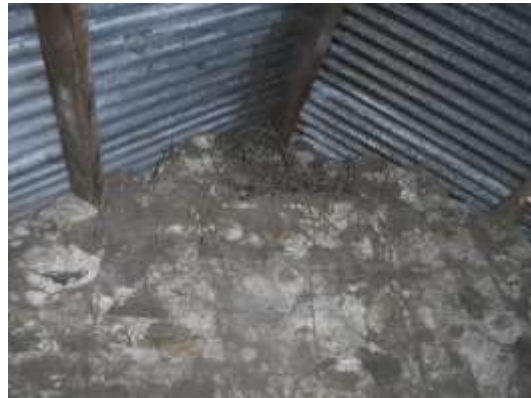
The slight inward lean of the gable pike to the south-east elevation appears likely due to the removal of the stone internally local to the pike. Whilst the degree of out of alignment is not structural significant as this time, it is recommended that this is locally rebuilt to ensure long term structural stability.

34 - inside of room 1 - external gable pike - note missing stonework
